Estimating extreme level ice and ridge thickness for offshore wind turbine design

Tikanmäki, Maria; Heinonen, Jaakko

Published in:
Wind Energy

Estimating extreme level ice and ridge thickness for offshore wind turbine design: Case study Kriegers Flak

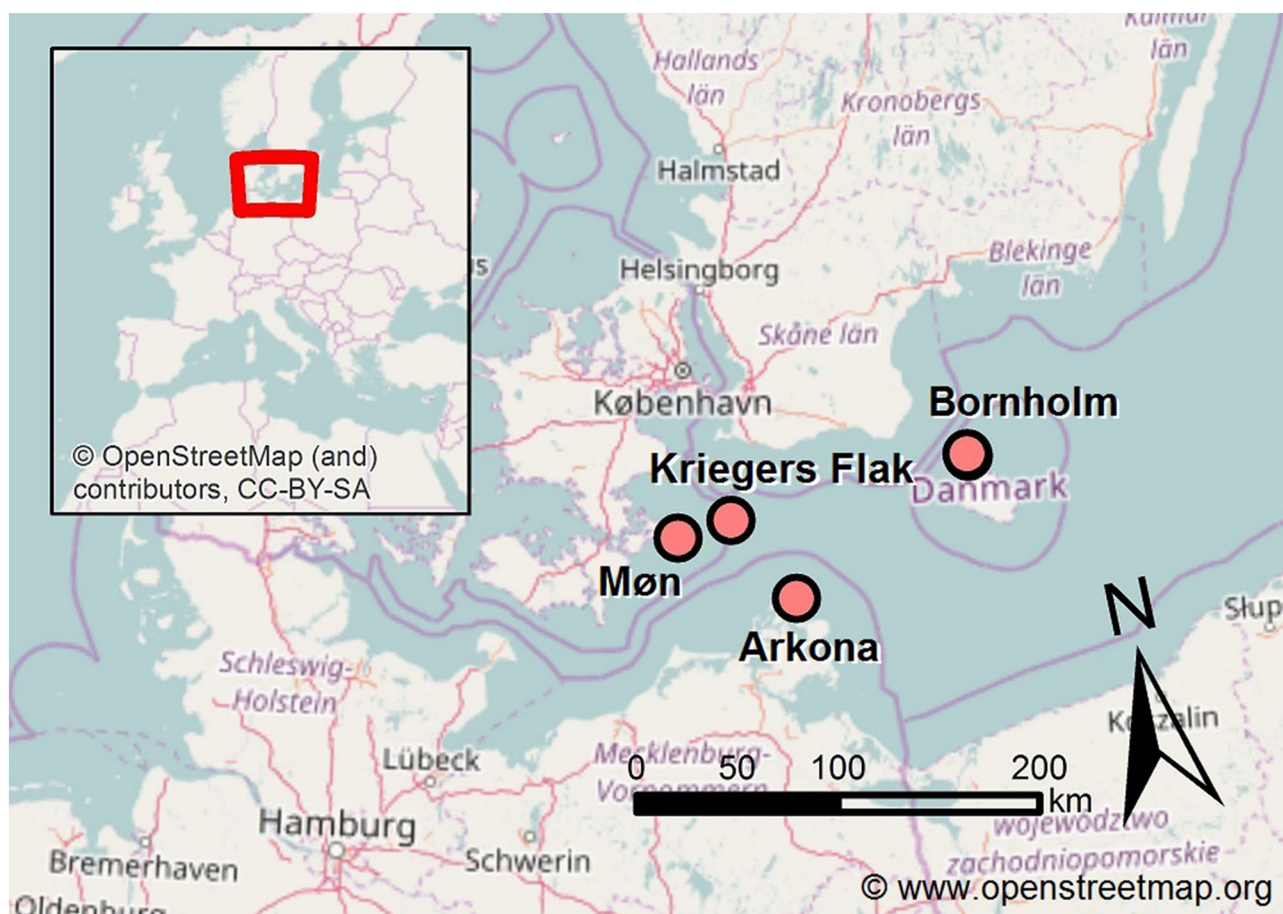
FIGURE 1 The location of the offshore wind farm Kriegers Flak and the utilized weather stations on islands of Møn, Rügen (denoted 'Arkona') and Bornholm [Colour figure can be viewed at [wileyonlinelibrary.com](https://onlinelibrary.wiley.com)]

In this paper, we concentrate on estimating ice conditions for offshore wind turbine design in areas where no direct ice thickness measurements on site exist. Methods to estimate both the maximum level ice thickness occurring once in 50 years at the wind farm site and the ice ridge parameters, especially the thickness of the consolidated layer, are presented. We take the Kriegers Flak wind farm in the Southern Baltic Sea as a case study. Kriegers Flak is an offshore wind farm site at the Arkona Basin in Danish waters of the Southern Baltic Sea. The central point of Kriegers Flak is located in 55.0270°N and 12.9390°E. The location of the Kriegers Flak is shown in Figure 1.

The applied air temperature histories are from four different measurement stations: Arkona, Møn Lighthouse, Hammer Odde Lighthouse, and Sandvig. The measurement station Arkona is located at the Northern part of the German island of Rügen. The data are from Deutscher Wetterdienst.²⁸ Møn Lighthouse is located at the Danish island of Møn. This station is closest to the site of Kriegers Flak, and thus it would have been the best source of the temperature histories. Unfortunately, it only started to measure temperature from 1977 onwards. The Møn data are from Danish Meteorological Institute.²⁹ The Hammer Odde Lighthouse and Sandvig are located at the Northern part of the Danish Bornholm Island. Their data are combined together, and it is called the Bornholm data in this report. The Bornholm data were available as daily maximum and minimum temperatures instead of daily mean temperature.³⁰ Thus, the daily mean temperature was estimated to be a mean of the daily maximum and minimum temperature. Detailed information of the weather stations and applied weather data are presented in Table 1. The places of the weather stations can be found from Figure 1.

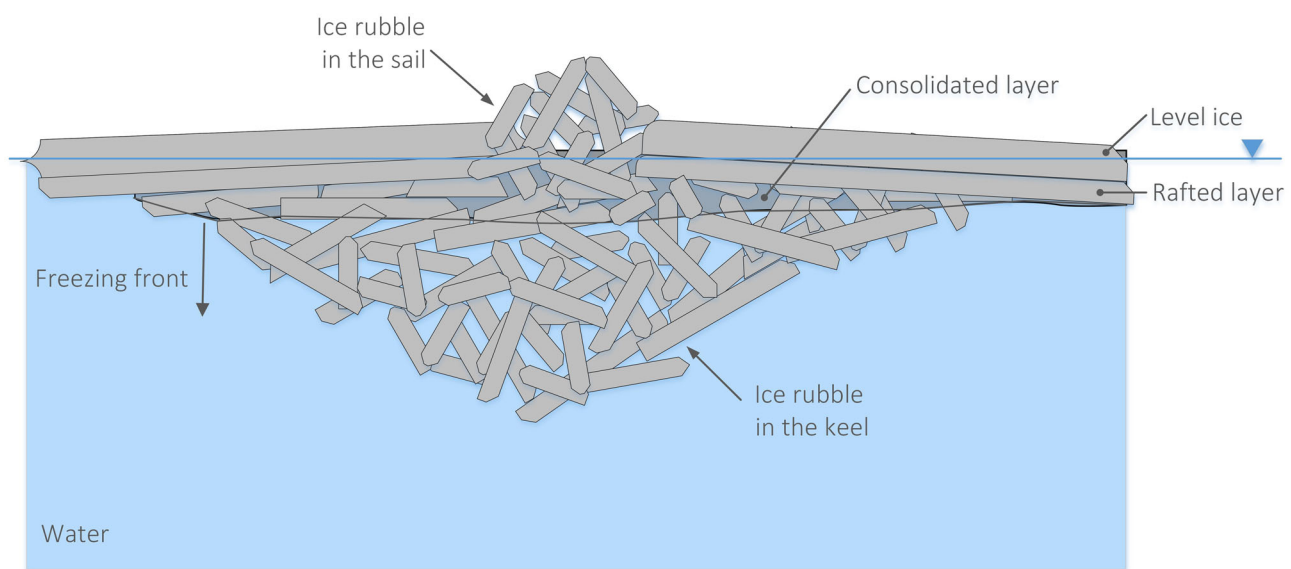
FIGURE 2 Schematic illustration of the cross section of a ridge. During the consolidation the water between the ice blocks freezes to form a solid refrozen layer with the initial ice rubble. The freezing front progresses downwards [Colour figure can be viewed at wileyonlinelibrary.com]

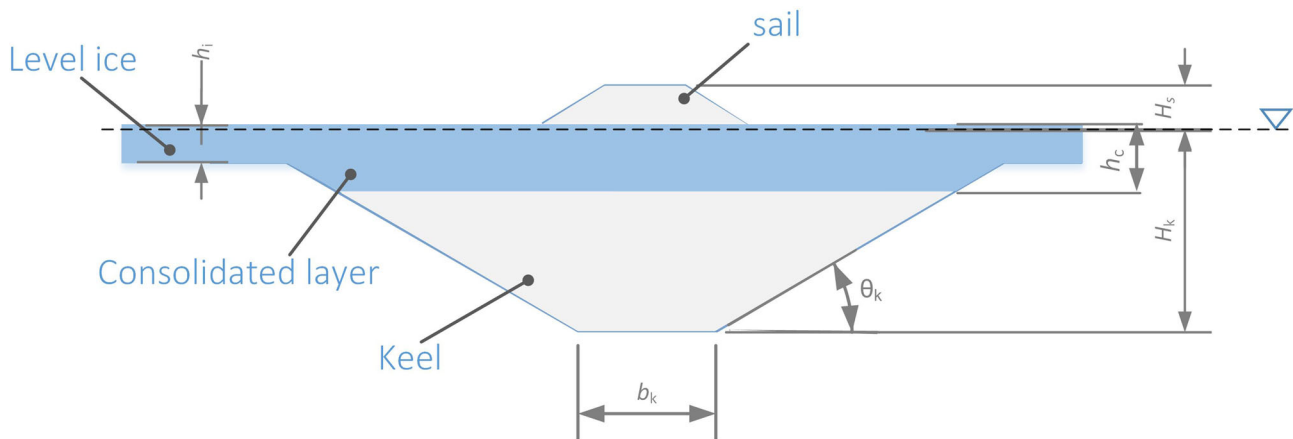
FIGURE 3 Idealized geometry of a first-year ridge. Schematic drawing redrawn based on the ISO 19906.²⁶ h_i is the level ice thickness H_s is the sail height, H_k is the keel depth, h_c is the thickness of the consolidated layer, b_k is the width of the keel bottom and θ_k is the keel angle [Colour figure can be viewed at wileyonlinelibrary.com]

where H_s is the height of sail and H_k the depth of keel, both of them measured from the water level (Figure 3). For the comparison, similar empirically determined correlation between the level ice thickness and the ridge keel was found by Amundrud et al.³¹ Based on their observations of seasonal pack ice in the Beaufort Sea during the 1990s, they found out that the keel thickness $H_k = 20\sqrt{h_i}$. By combining the two expressions in Equation (8), we find $H_k = 17.8\sqrt{h_i}$.

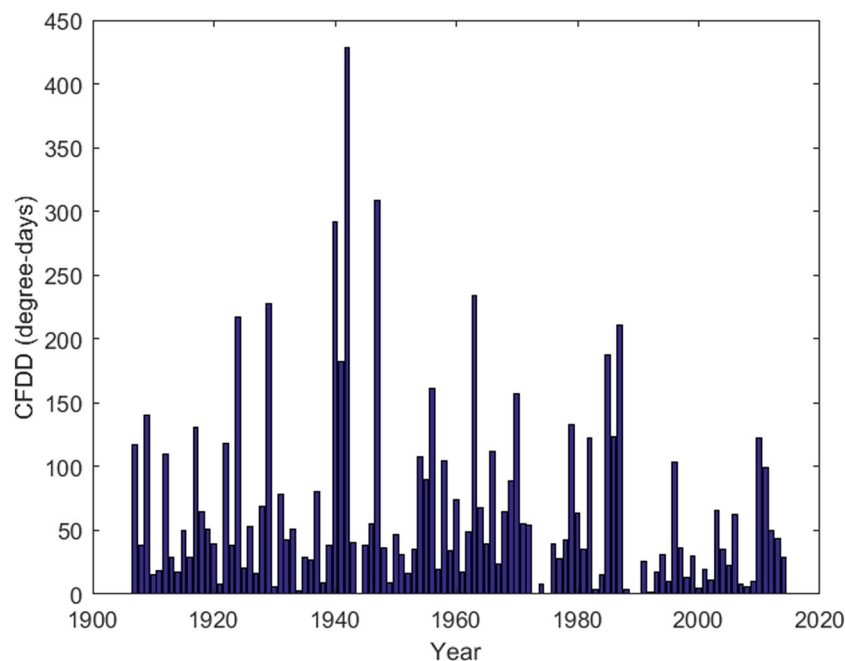
FIGURE 4 Cumulative freezing degree-days from the Bornholm data [Colour figure can be viewed at wileyonlinelibrary.com]

The CFDDs from the Bornholm data are shown in Figure 4. It can be seen that ice was present at the site only when CFDD was over 100 degree-days calculated from the Bornholm data. In some years, CFDD was over 100 degree-days, but the existence of ice was not probable based on the other available information. In general, it was noted that the higher the calculated CFDD value the more severe ice conditions were reported also in the other sources.

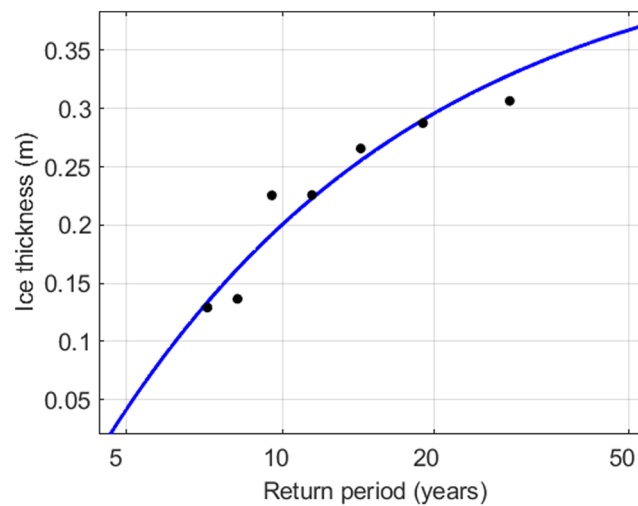
FIGURE 5 Return period of the maximum ice thickness in the site of Kriegers Flak based on the thermal growth of ice without snow cover. The growth is calculated from the temperature history measured from the Arkona station, and the covered time period is years 1963–2019 [Colour figure can be viewed at wileyonlinelibrary.com]
